**Company Name:** 4-9 Herschel Close RTM Company Limited

**Inspector Name:** K.Zak

**Inspection Date:** 22 April 2025

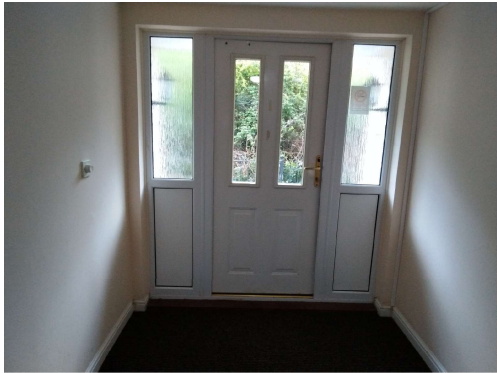
**Entrances (Main Doors)**

Internal Inspection	Acceptable	Not Acceptable	N/A	Comments	Action
<b>Entrances</b> (Main doors)	✓			Main entrance doors were secure and operated without issue.	None
<b>Hallway</b> (Communal Lobbies and Stairs)	✓			Hallways and stairs were clean, clear and free from obstructions.	None
<b>Lighting</b> (Standard and Emergency Lighting)	✓			Lighting, including emergency units, is operational with no faults reported.	None
<b>Internal Doors</b> (Compartment Doors)	✓			Internal compartment doors operated as intended and were damage-free.	None
<b>Cupboard Doors</b> (Electrical Cupboard Doors)	✓			Electrical cupboard doors were secured and free from visible damage.	None
<b>Windows</b> (Communal Windows)	✓			Communal windows appeared clean and fully operational.	None
<b>Signage</b> (Communal Notices)	✓				None
<b>Additional Comments</b>	Internal areas are in satisfactory condition overall.				None

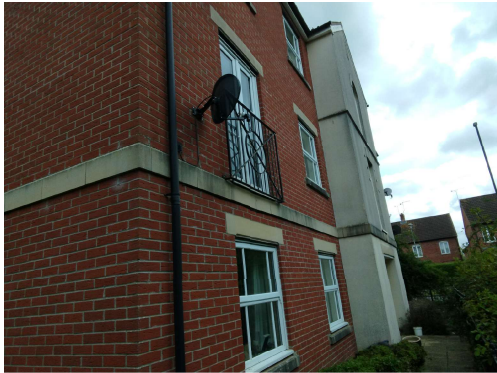
**Exterior Structure (The Building)**

External Inspection	Acceptable	Not Acceptable	N/A	Comments	Action
<b>Exterior Structure</b> (The Building)	✓			No signs of damage or wear were visible on the building's exterior.	None
<b>Guttering</b> (Gutters and Fascia)	✓			Guttering and fascia are intact, with no blockages or damage observed.	None
<b>Roofing</b> (Tiles and Cladding)	✓			Roofing inspected from ground level – no signs of damage noted.	None
<b>Communal Grounds</b> (Gardens and Common Areas)	✓			Communal grounds were tidy, well-kept, and free from litter.	None
<b>Bin Store</b> (Waste Disposal Areas)	✓			Waste disposal area is in good condition and appropriately used.	None
<b>Car Park</b> (Vehicle Parking)	✓			Parking area is in good visual and functional condition.	None
<b>Bike Store</b> (Bicycle Areas)			✓		None
<b>Additional Comments</b>					None
