COMBINED FIRE AND HEALTH & SAFETY RISK ASSESSMENT.

Address of premises:	4-9 Herschel Close Oakhurst SN25 2HX
Responsible Person:	4-9 Herschel Close RTM Company Limited
Duty Holder:	Block Management Limited
Person(s) consulted:	No occupier or other relevant person available to consult.
Assessor:	Rob Cockburn
Report validated by:	John Godfrey, GIFireE.
Date of fire risk assessment:	31 st October 2025
Date of previous fire risk assessment:	September 2023
Suggested date for review:	October 2026

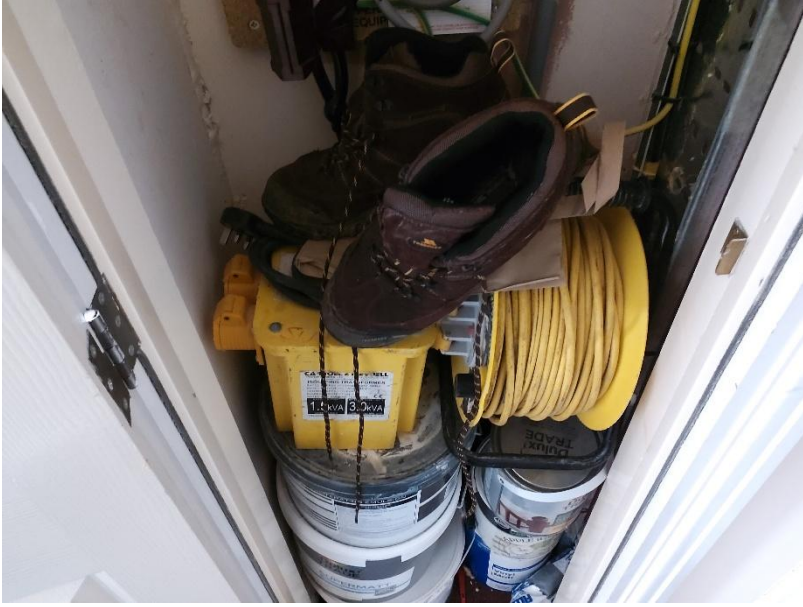
Item	Recommendation	Priority	Timescale
01	<p>Housekeeping was found to be of a poor standard at the time of this assessment with the communal areas and escape routes and communal cupboards were congested with residents' possessions and storage. It is recommended that the client arrange for the communal areas and cupboards to be cleared as a priority and all residents reminded of the importance of maintaining sterile communal areas, communal cupboards and escape routes.</p>

Ongoing action required

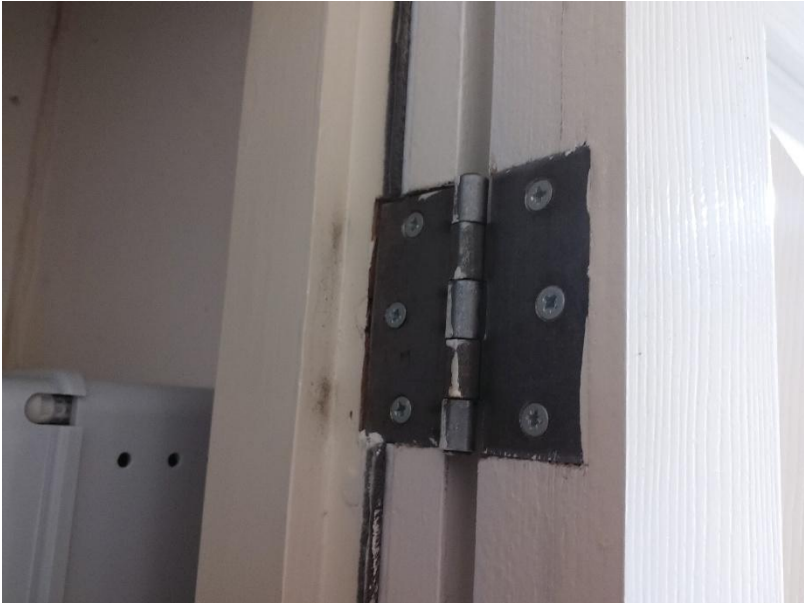
02	<p>It was noted during this fire risk assessment that the identified communal area doors had the following deficiencies:</p> <ul style="list-style-type: none"> • No fire rated hinges on all riser doors • Painted smoke seals on multiple riser doors • Missing screws top hinge of the ground floor lobby • The ground floor riser door outside flat 4 does not fully self-close <p>It is essential that each door communicating with the means of escape is a suitable fire door, providing a minimum of thirty minutes fire resistance, hung on three grade 13 hinges, combine cold smoke and intumescent seal, "Fire Door Keep Locked" or "Fire Door Keep Shut" signage where appropriate along with having a functioning self-closing device fitted that positively closes the door flush to the frame if a lobby door. It is recommended therefore that the RP instruct a suitably qualified and competent contractor to conduct a fire door inspection to all communal area doors providing advice on suitability as per "Fire Resisting Doors - 62.17" of Fire Safety in Purpose-Built Block of Flats. Any shortcomings identified by this inspection should be addressed as a priority by upgrading or replacing the door.</p> <p>Flat entrance doors, communal area doors, the seals and the self-closing devices should then be subjected to an annual inspection and maintenance schedule.</p>	1	B	<p>Ongoing action required</p> <p>Contractor to action deficiencies as appropriate.</p> <p>Inspection carried out in accordance with current legislation.</p>

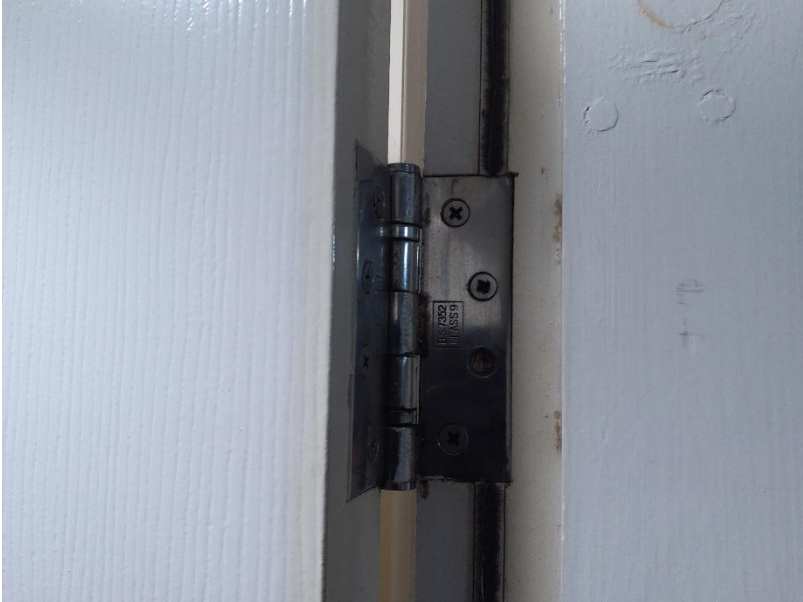
03	<p>As per section 33.2 of Fire Safety in Purpose-Built Block of Flats a type 1 fire risk assessment requires us to conduct a fire door survey on a sample of flat front doors. The door to flat 9 was surveyed during this sample in which the following deficiency was found:</p> <ul style="list-style-type: none"> • Missing screws on the middle hinge. <p>It is essential that each flat entrance door is a suitable fire door, providing a minimum of thirty minutes fire resistance, hung on three grade 13 hinges and having a functioning self-closing device fitted that positively closes the door on the latch, together with smoke and intumescent seals. It is recommended therefore that the RP instruct a suitably qualified and competent contractor to conduct a fire door inspection to all flat entrance doors providing advice on suitability as per “Fire Resisting Doors – 62-12 to 62.17” of Fire Safety in Purpose-Built Block of Flats. Any shortcomings identified by this inspection should be addressed as a priority by upgrading or replacing the door.</p> <p>Flat entrance doors, communal area doors, the seals and the self-closing devices should then be subjected to an annual inspection and maintenance schedule.</p>

2	B	<p>Ongoing action required</p> <p>Owner has been informed accordingly</p> <p>Inspection arranged per current legislation</p>

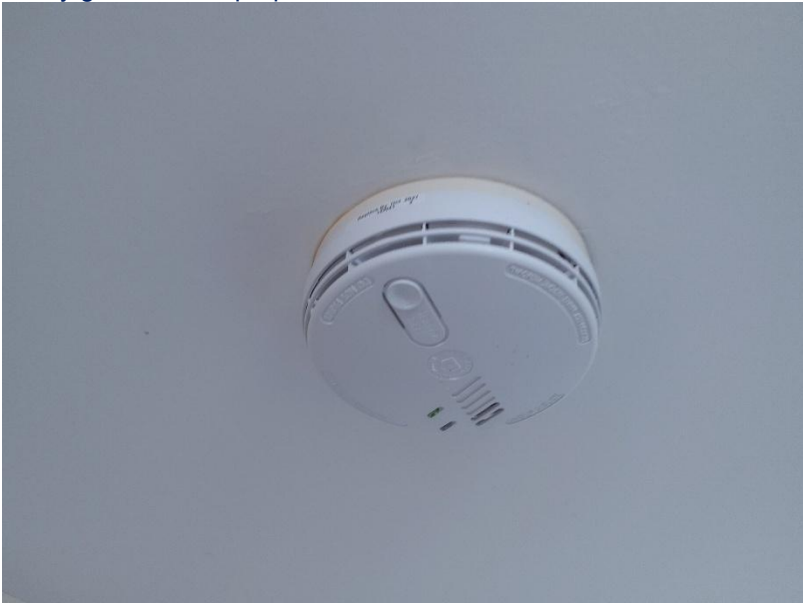
05	<p>It was noted during this fire risk assessment that hard wired smoke detectors were installed within the premises. This could be considered as an overprovision for this purpose-built block of flats implementing a stay put evacuation policy. Consideration could be given by the RP as to their removal. This is in line with current fire safety guidance for purpose-built flats.</p>

2	C	<p>Action required RP to consider removal</p>
06	<p>It is recommended that a suitable written record of periodic visual inspections of all access routes to the premises is implemented by the RP. This should include a record of the condition of external steps and pathways. Any defects identified should be communicated to each resident and repaired by an approved contractor as a priority.</p>	3	C	<p>Ongoing action required DH inspect and action as required</p>
07	<p>It is recommended that a suitable written record of periodic visual inspections of all other external communal areas is implemented by the RP, which should identify any potential hazards including slips or trips from major indentations or imperfections in any surface, including hard and soft landscaping. Any defects identified should be communicated to each resident and repaired by an approved contractor as a priority.</p> <p>Where refuse compounds are identified, an observation regarding waste management should be made as infrequent collections could result in broken glass in the vicinity of the compound leading to possible injury to playing children and a build-up of food waste, which would attract vermin such as foxes, rats or mice.</p>	3	C	<p>Ongoing action required As above</p>
